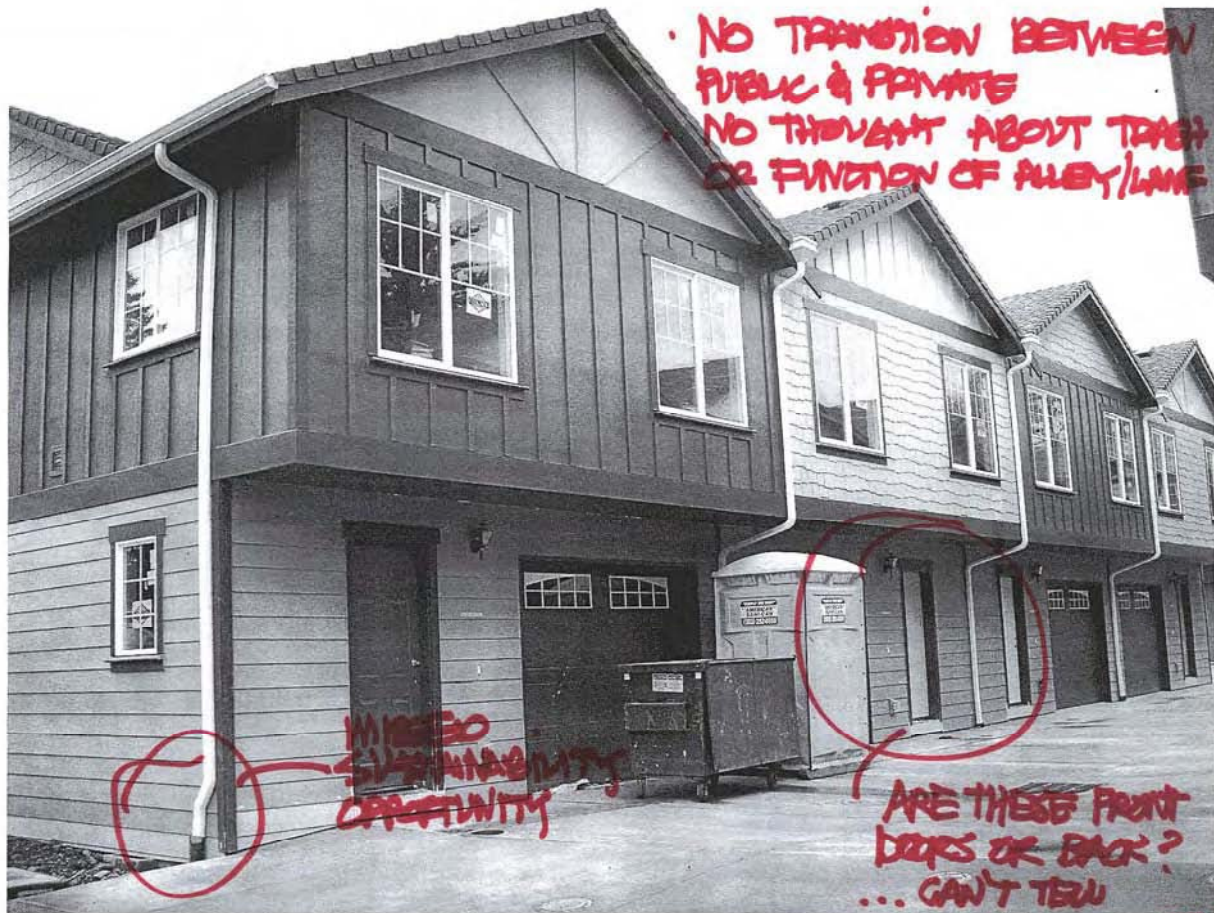
- There is no transition between the public and private realms.
- There is no thought about trash or the function of the alley / lane.
- There is a missed sustainability opportunity.
- It is unclear if the entrance is the front or rear entrance.

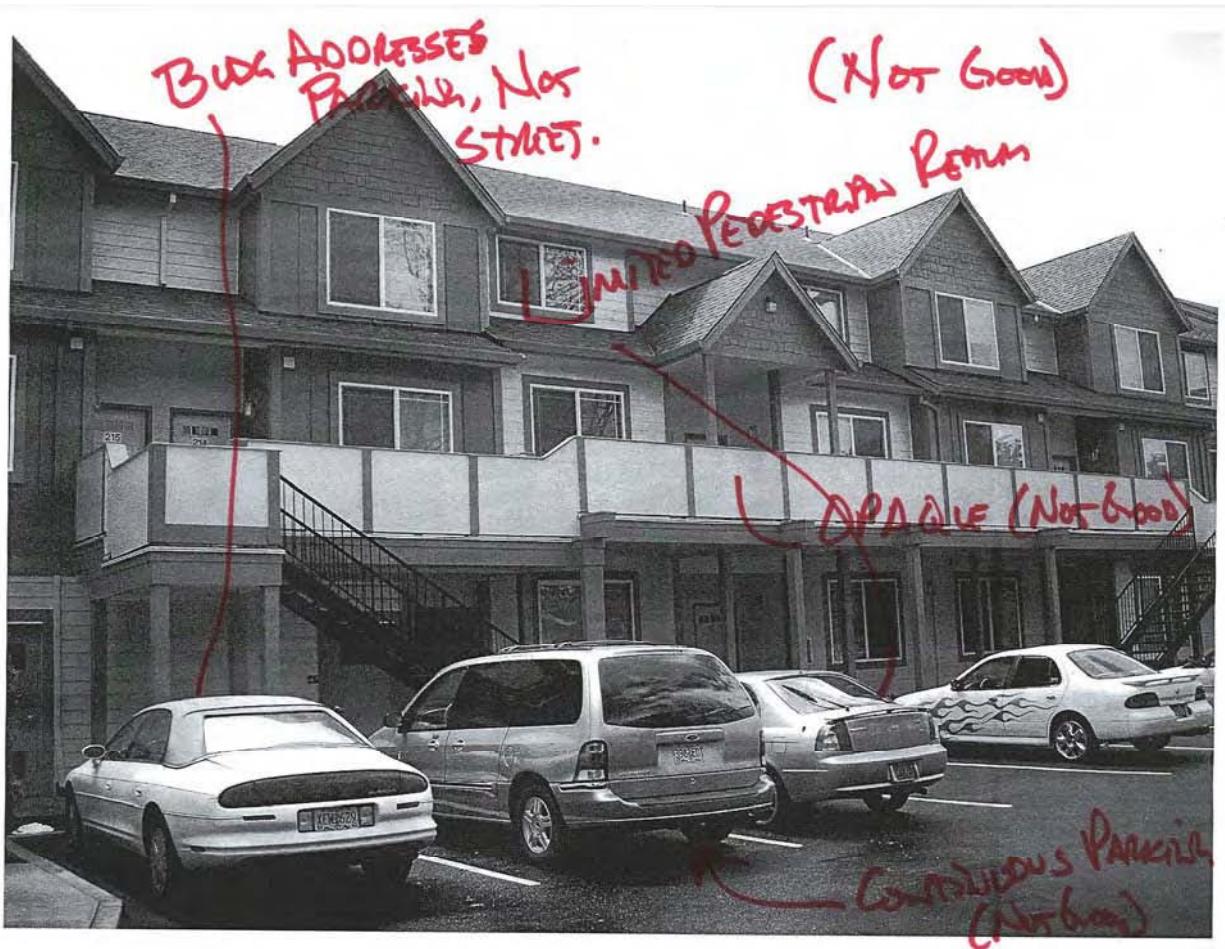
- The building addresses the parking lot, not the street.
- There is a limited pedestrian realm and the railing is opaque, which is not good.
- The continuous parking is also a negative aspect.

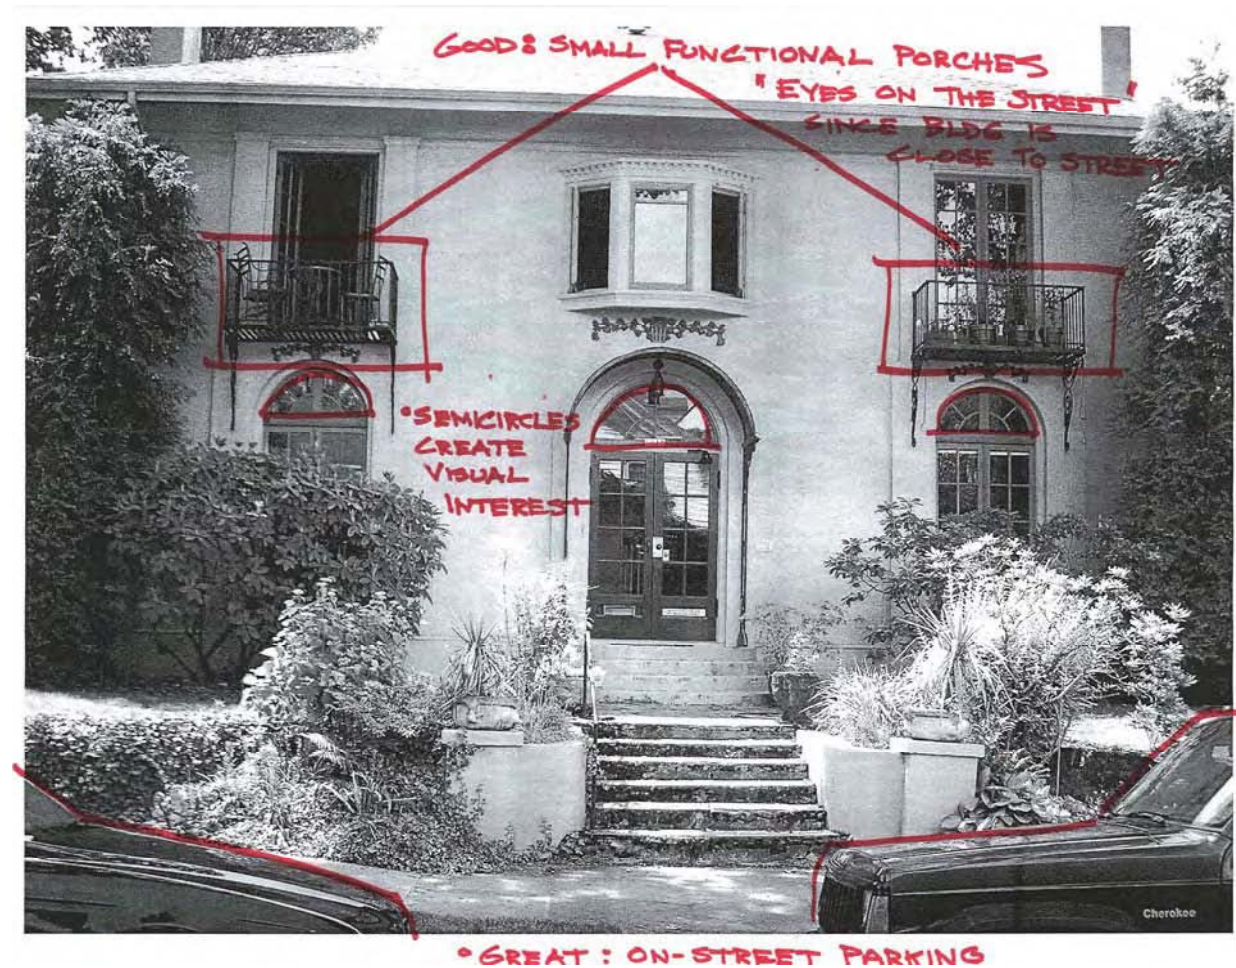
- The small functional porches allow for “eyes on the street” since the building is close to the street.
- The semicircle windows create a visual interest.
- On-street parking is present, which is another positive aspect of the site.

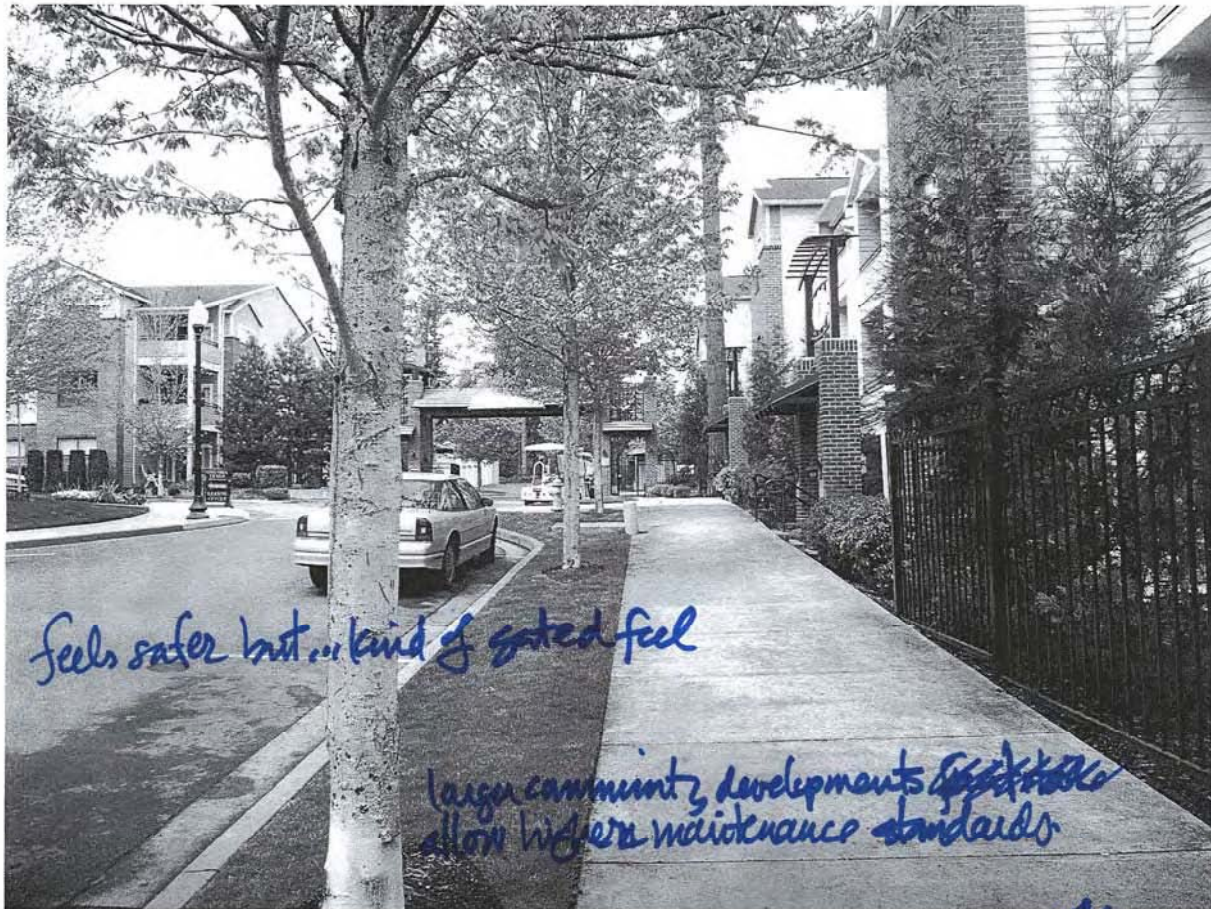
- While this site has a connotation of safety, there is also a gated feel present.
- Larger community developments allow higher maintenance standards.

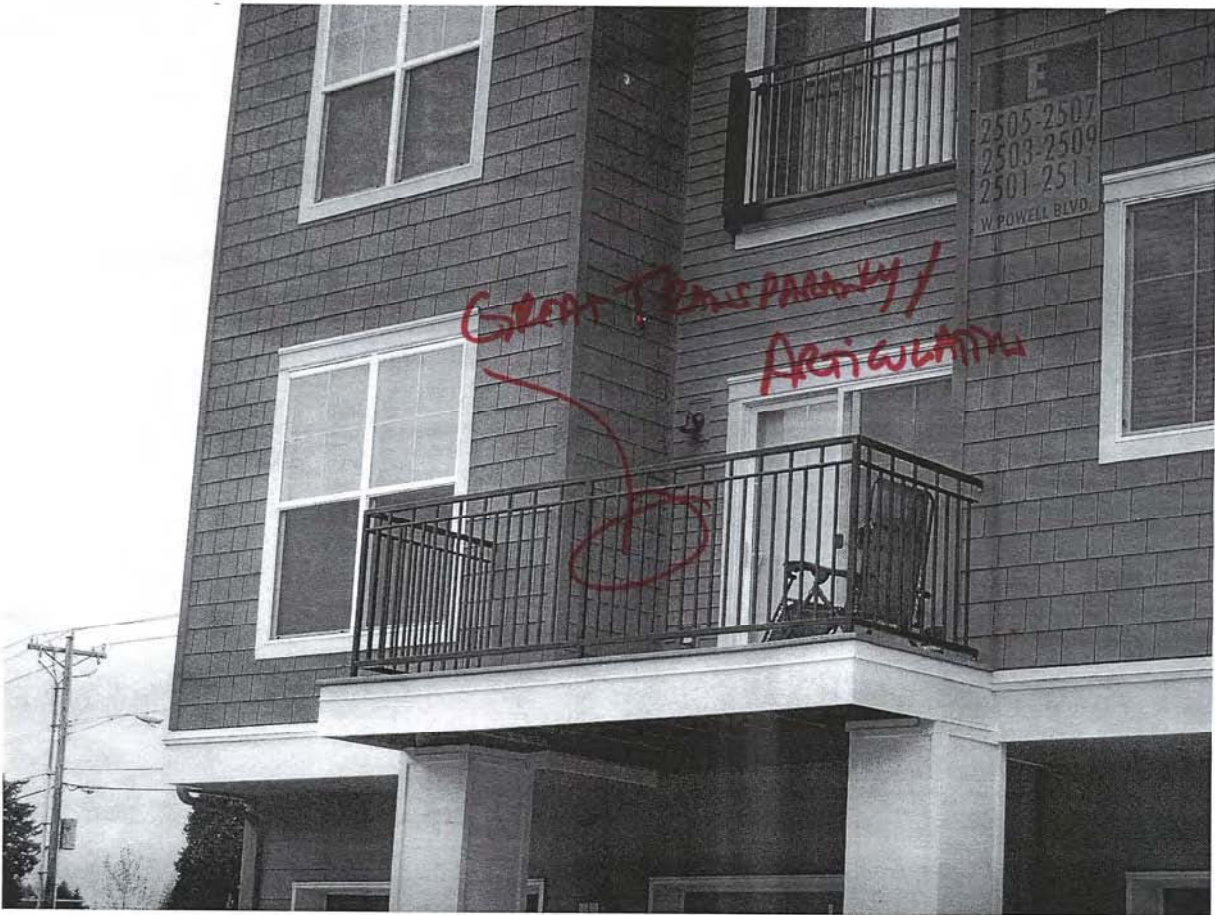
- The balcony displays great transparency and articulation.

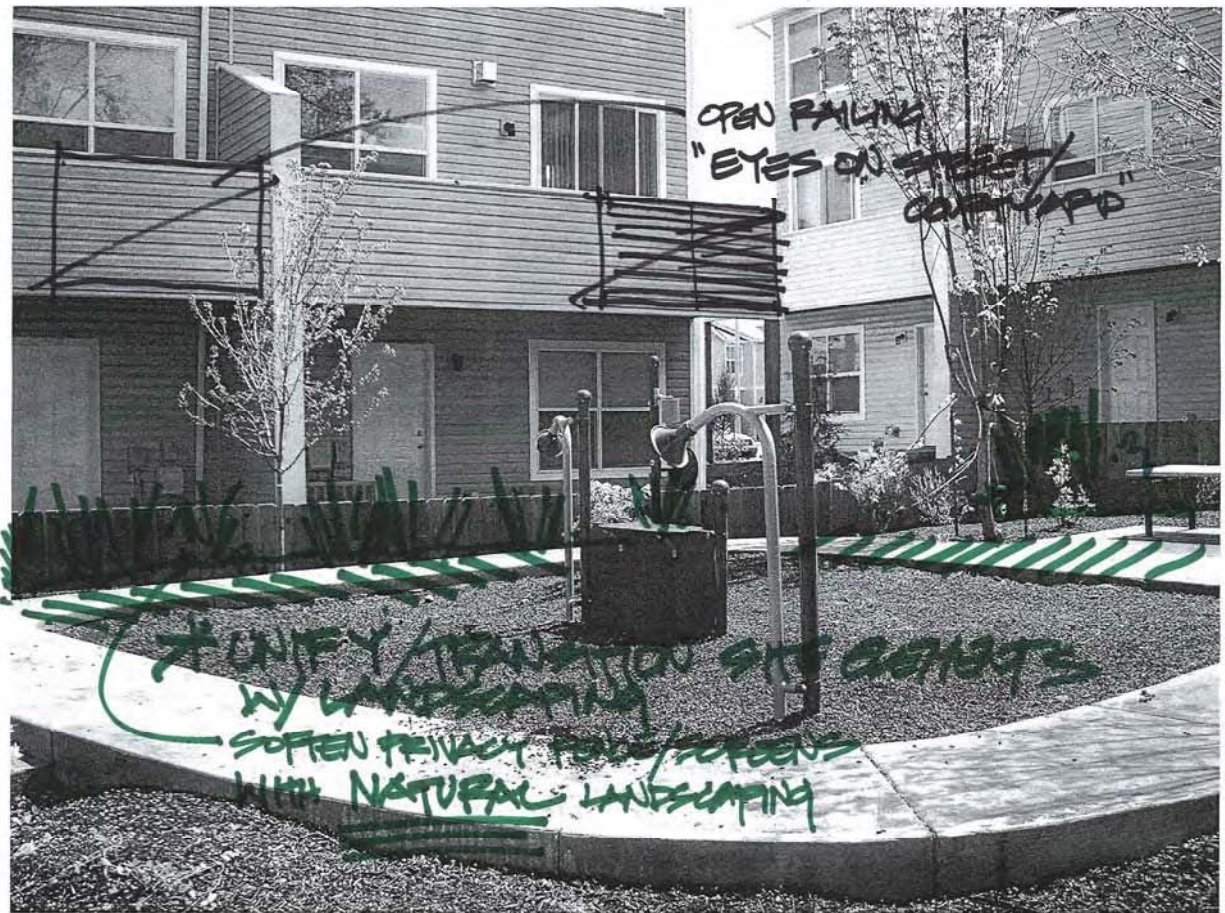
- An open railing would allow for “eyes on the street/courtyard.”
- Unify the transition of the elements with landscaping.
- Soften the privacy fence/screens with NATURAL landscaping.

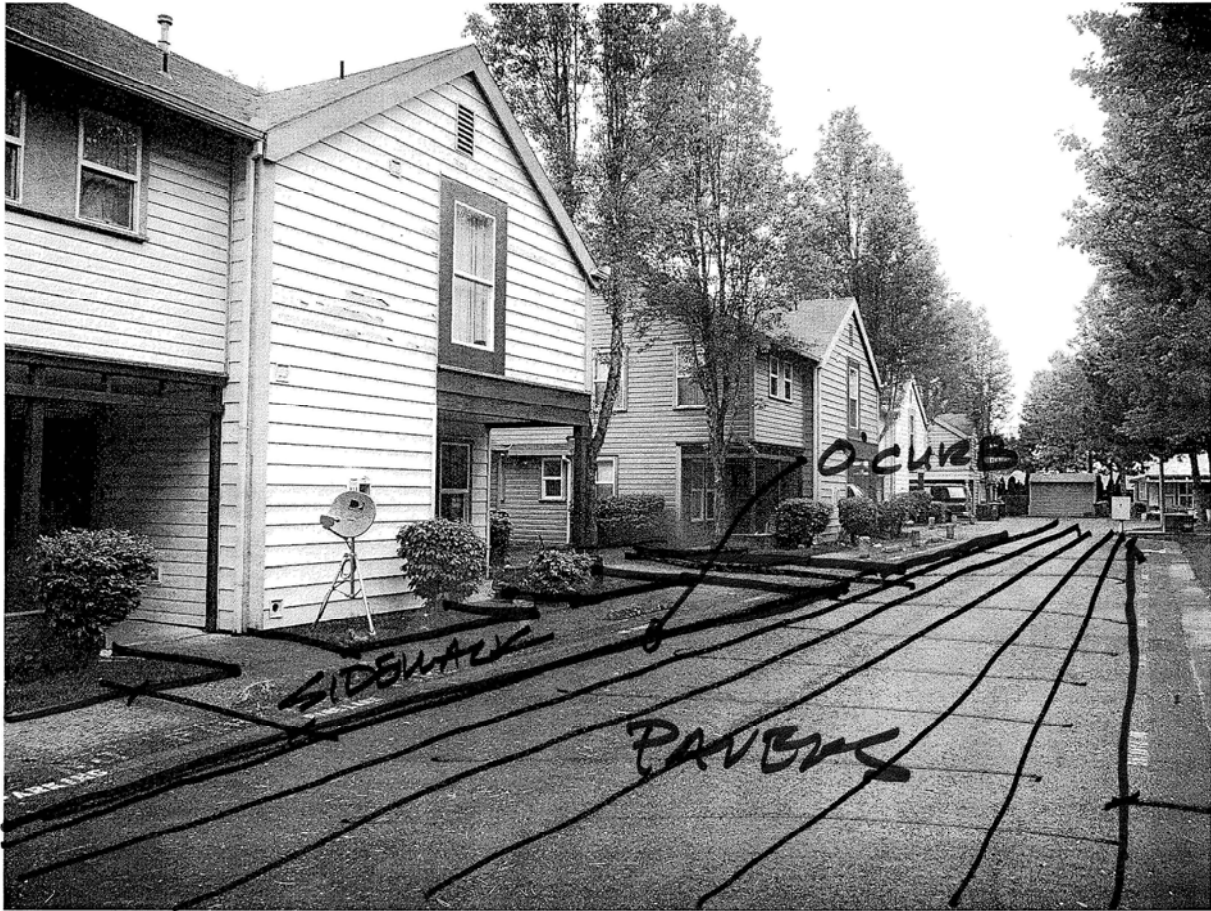
- The driveway should be composed of pavers and there should be a curb separation between the street and sidewalk.

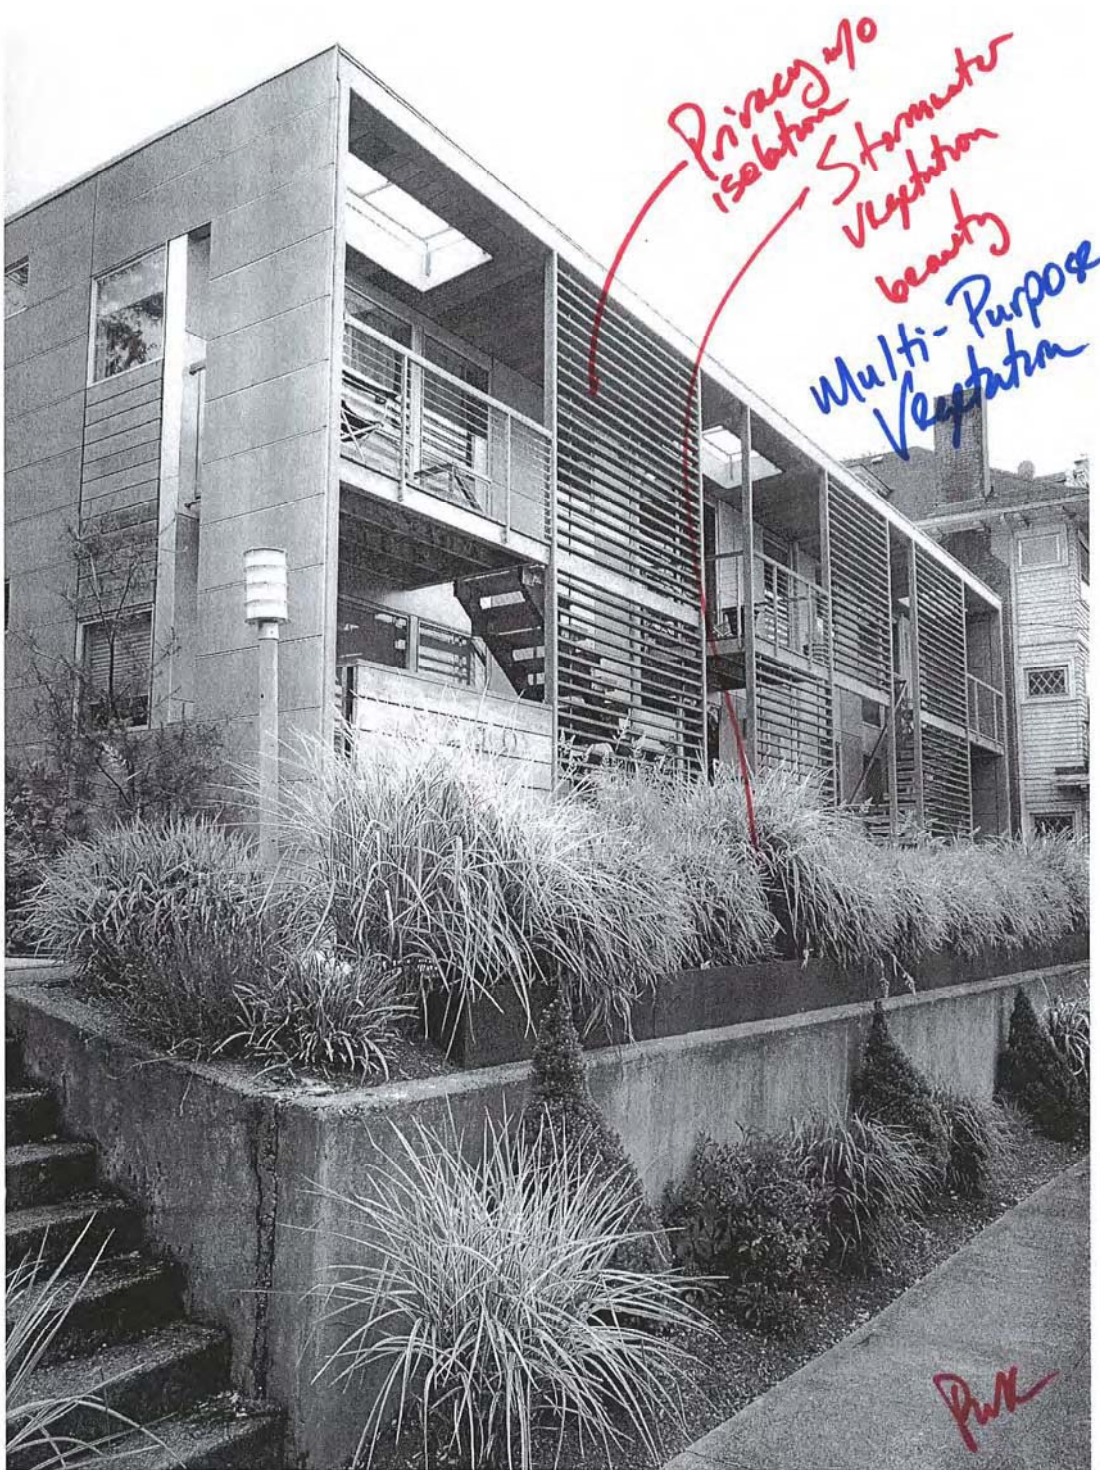
- This site demonstrates privacy without isolation.
- There is a stormwater and vegetation beauty as well.
- Also present is multi-purpose vegetation.

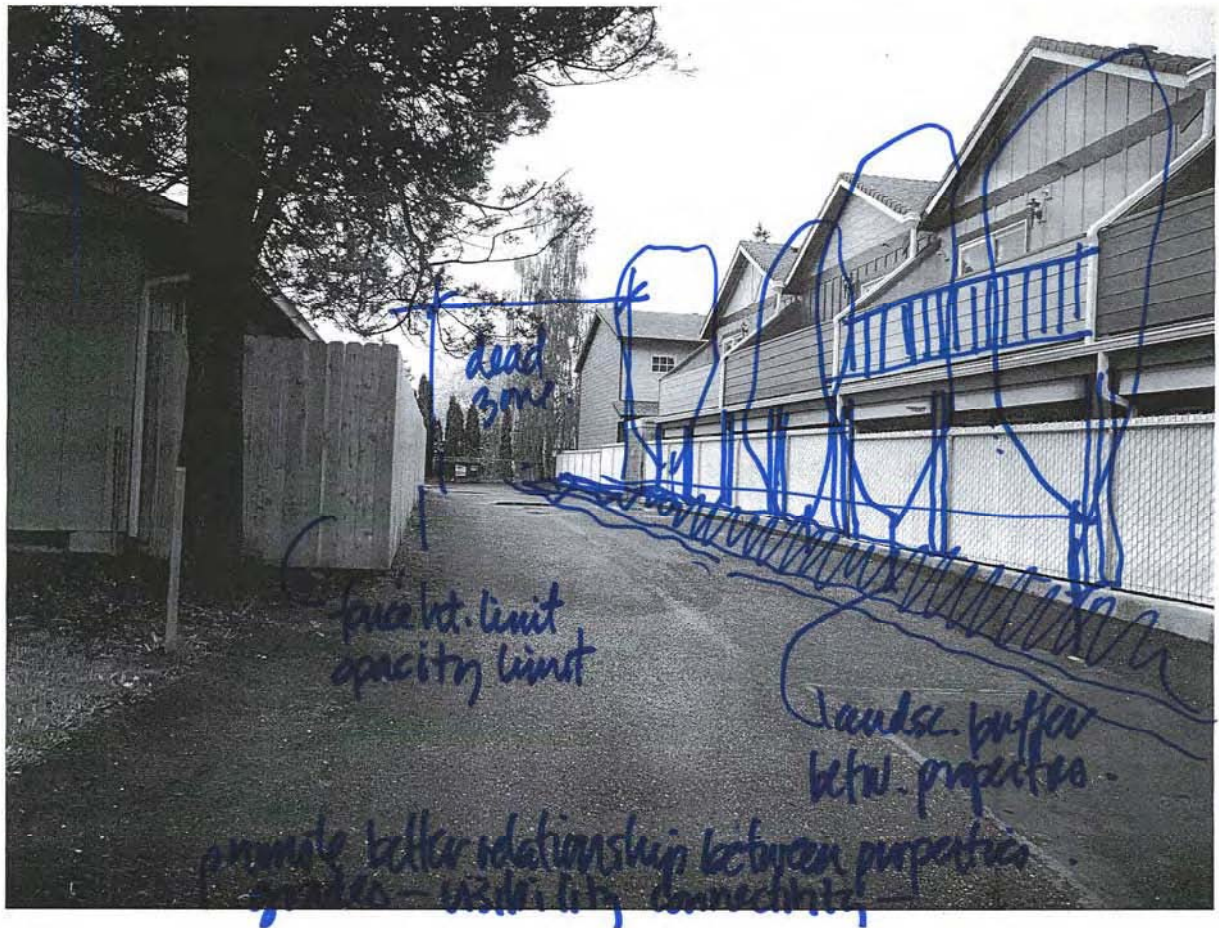
- In order to promote a better relationship between the properties, a landscape buffer between the two properties consisting of trees and a hedge should be installed.
- The space buffer requirement should be reviewed because it tends to create “dead zones.”
- The fence depicted may exceed the height limit.

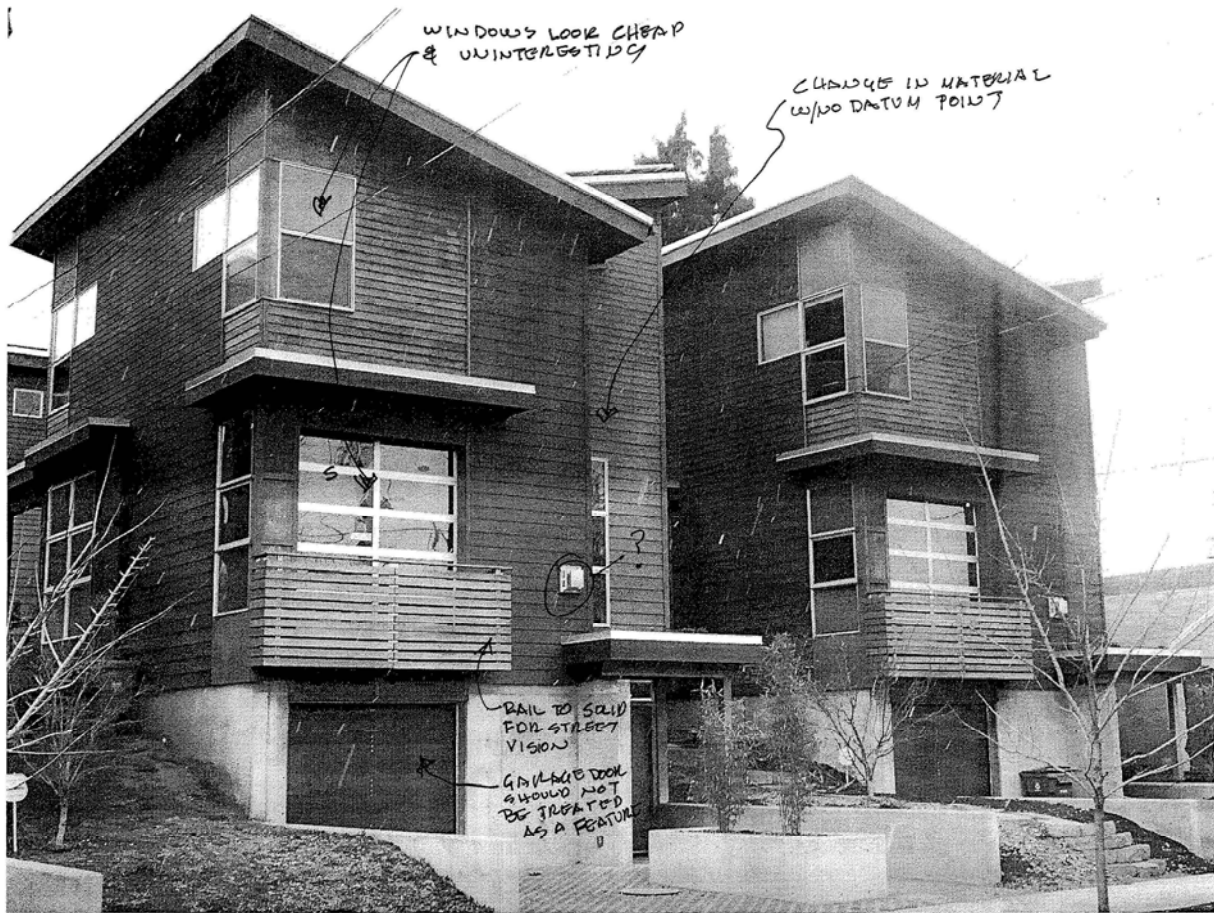
D.E

- The windows look cheap and uninteresting.
- There is a change in material with no datum points.
- The rail on the balcony is too solid for street vision.
- The garage door should not be treated as a feature.

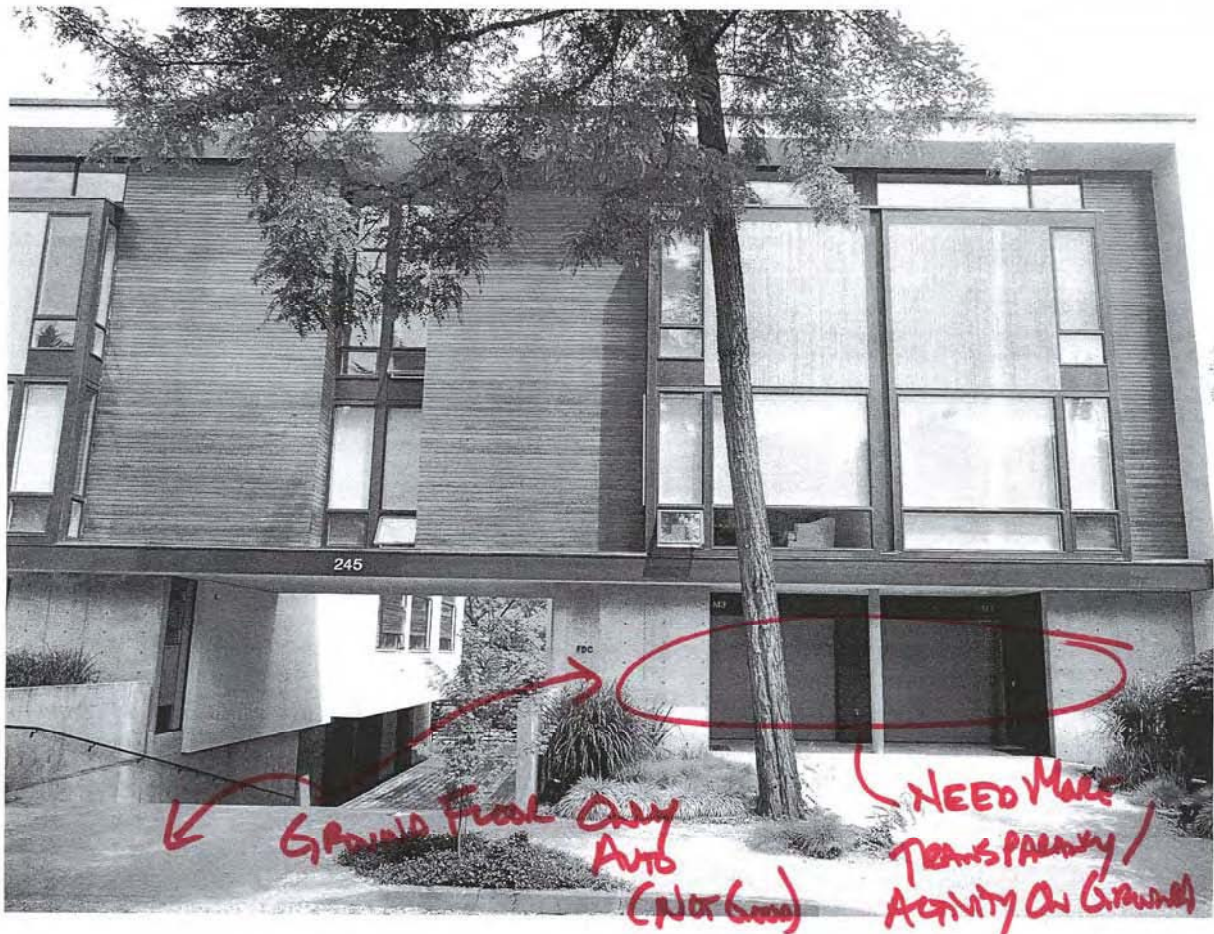
- More transparency/activity is needed on the ground floor.
- The ground floor is auto-oriented only, which is a negative aspect.

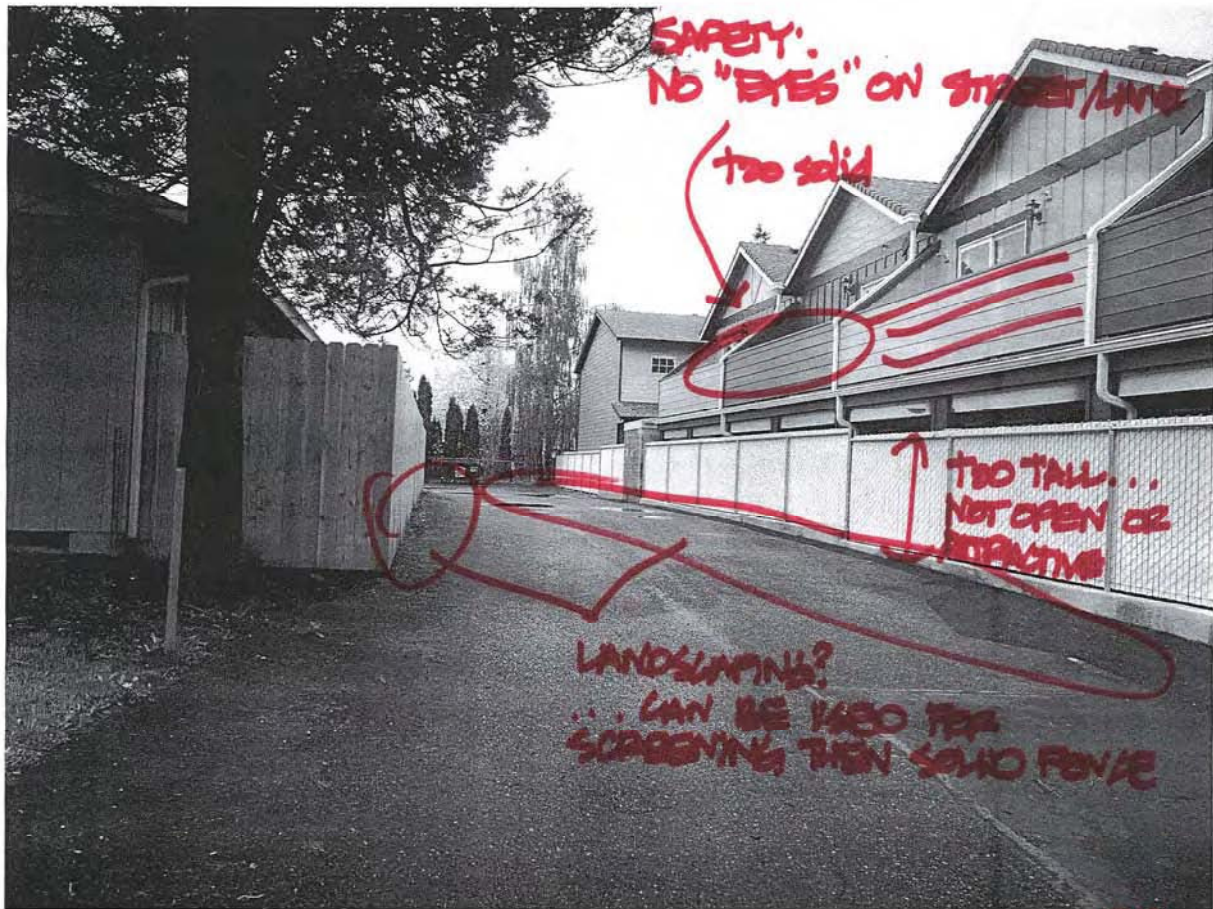
- The balconies are too solid and do not allow for “eyes on the street.”
- The fence is too tall and is not open or attractive.
- Landscaping could possibly be used for screening rather than using a solid fence.

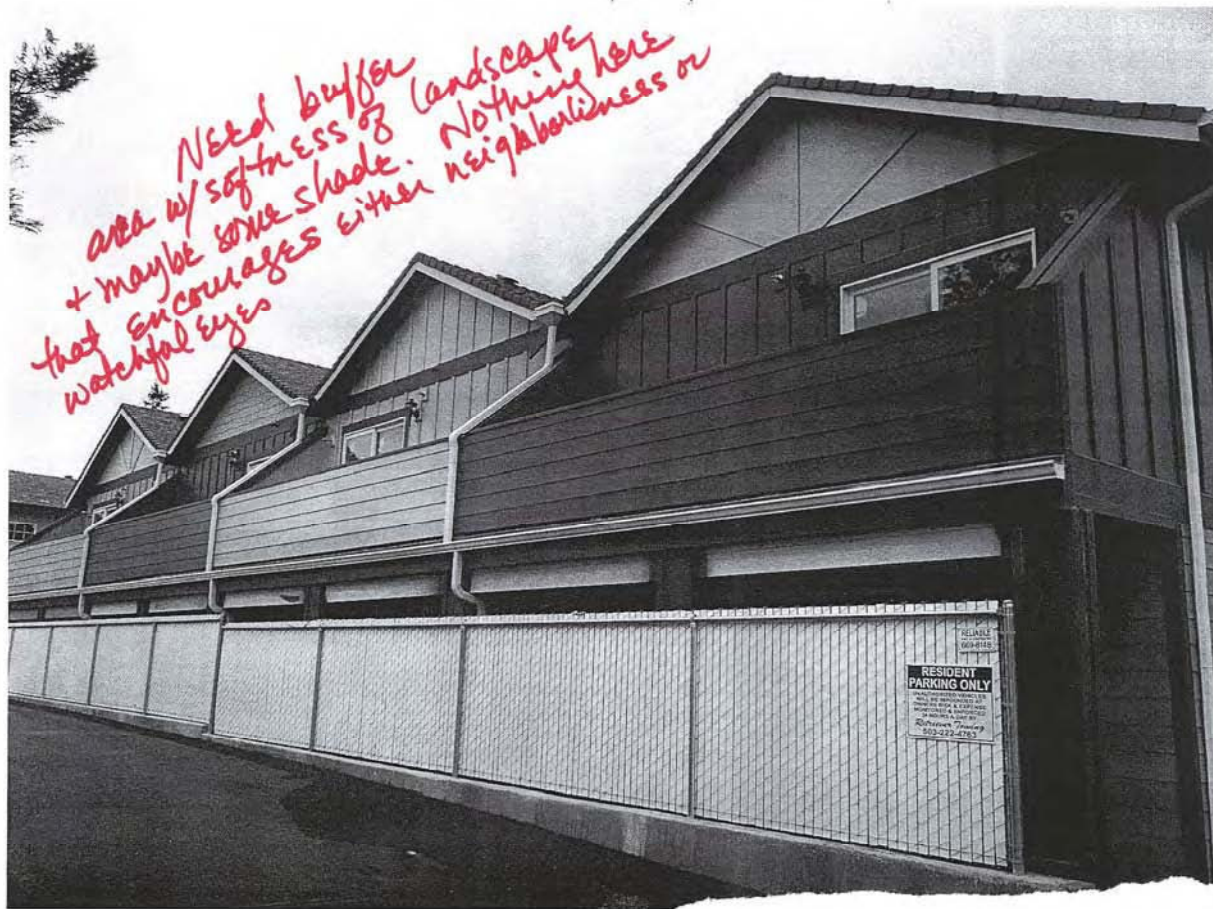
- A buffer should be incorporated into the area that includes the softness of landscape as well as provides shade.
- There are not any elements present that encourage either neighborliness or watchful eyes.

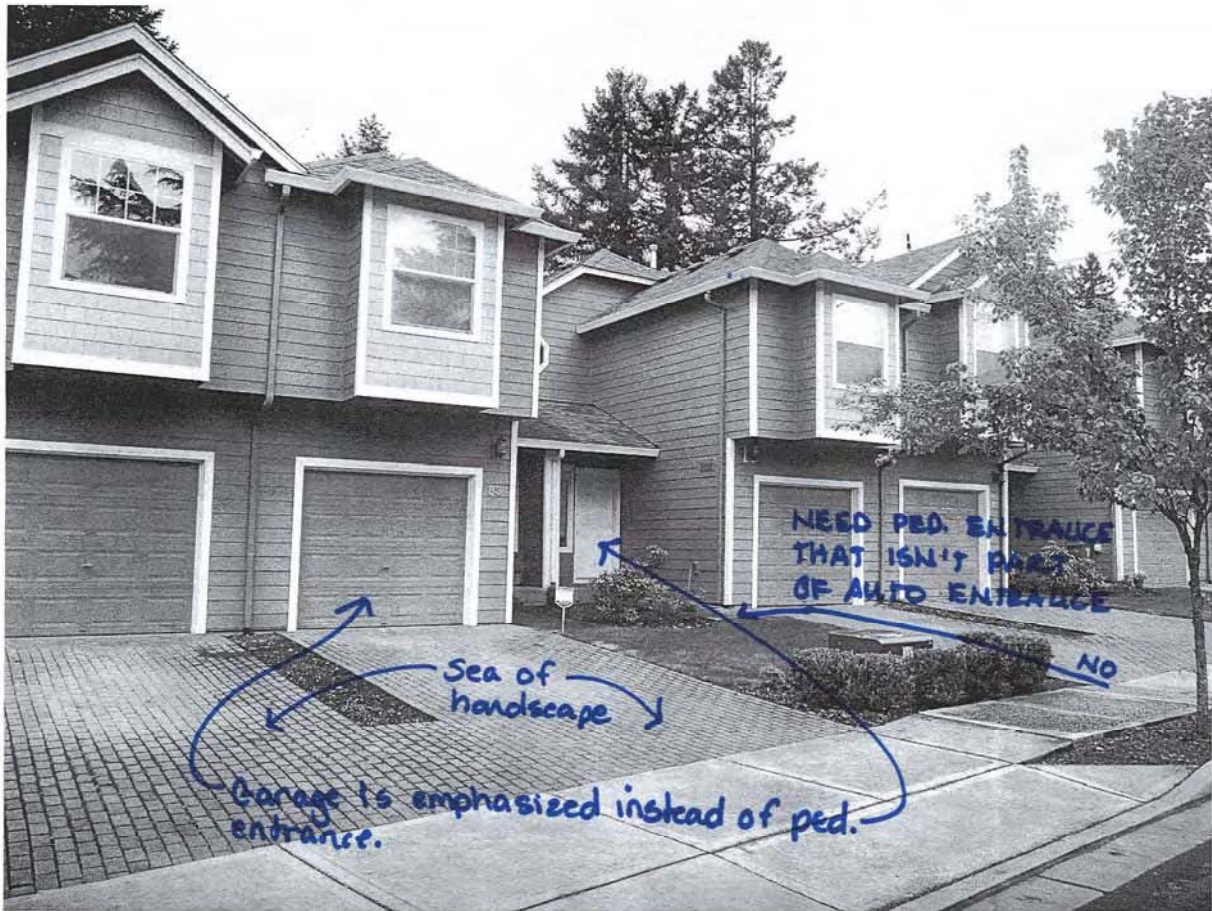
- The garage is emphasized rather than the pedestrian entrance; there should be a pedestrian entrance that is not part of the auto entrance.
- There is a sea of hard-scape.

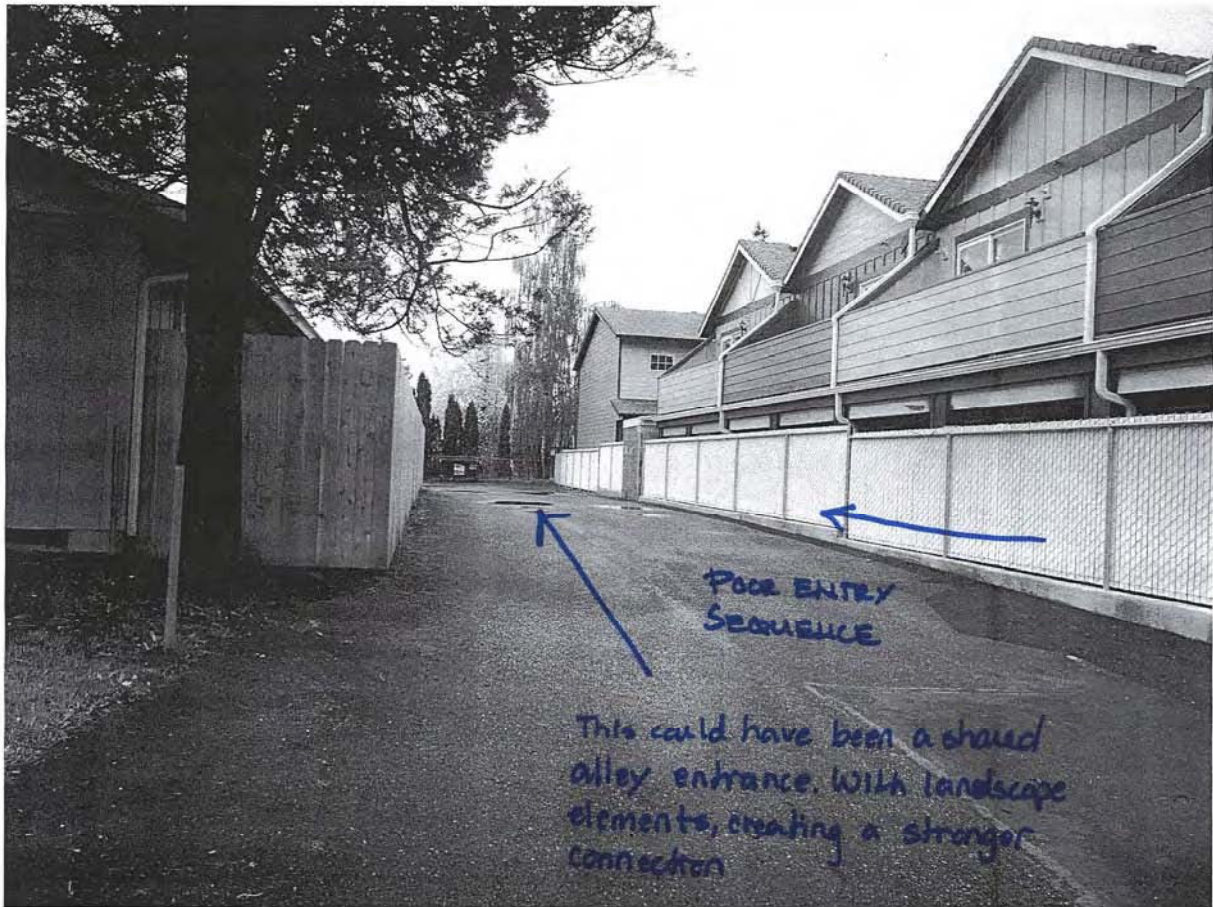
- The ally is a poor entry sequence.
- The ally could have been a shared ally entrance with landscape elements, creating a stronger connection between the two structures.

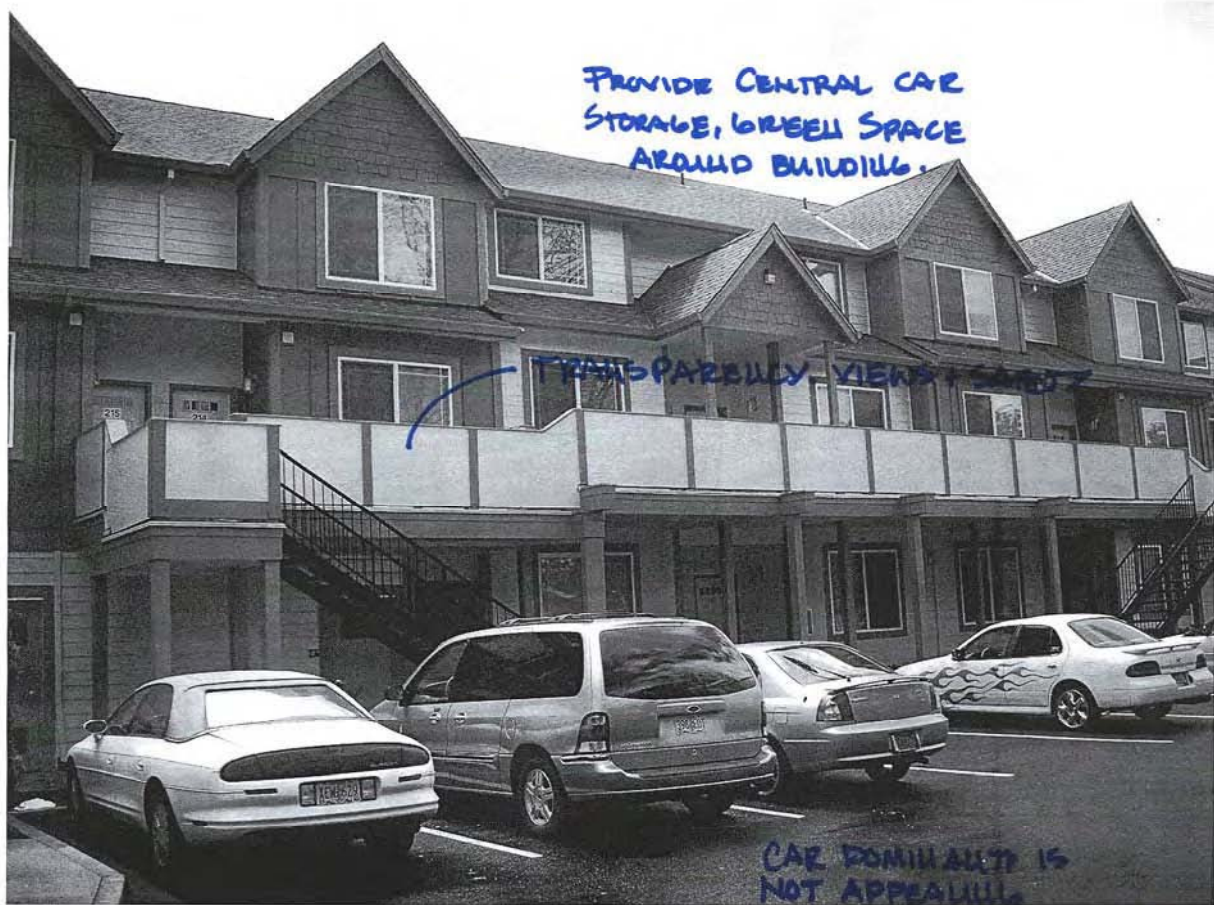
MH

- Central car storage should be provided with green space situated around the building.
- The solid balcony railing does not allow for transparency, which will not assist in safety.
- The domination of the car is not appealing.

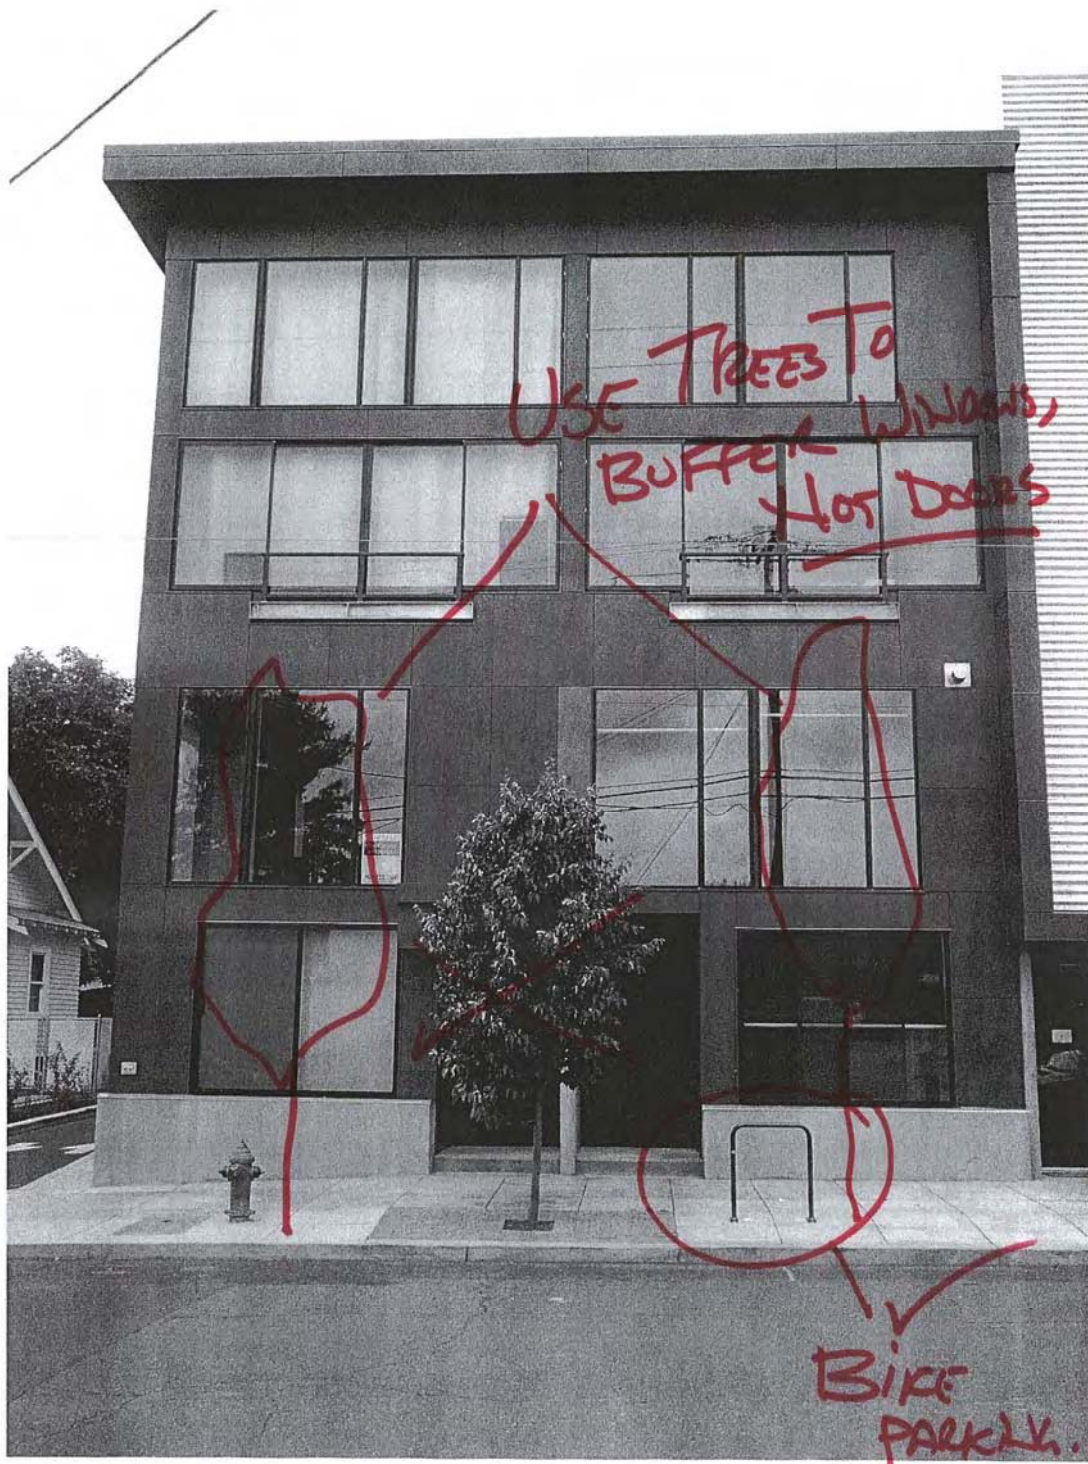
- The trees should be used to buffer windows rather than doors.

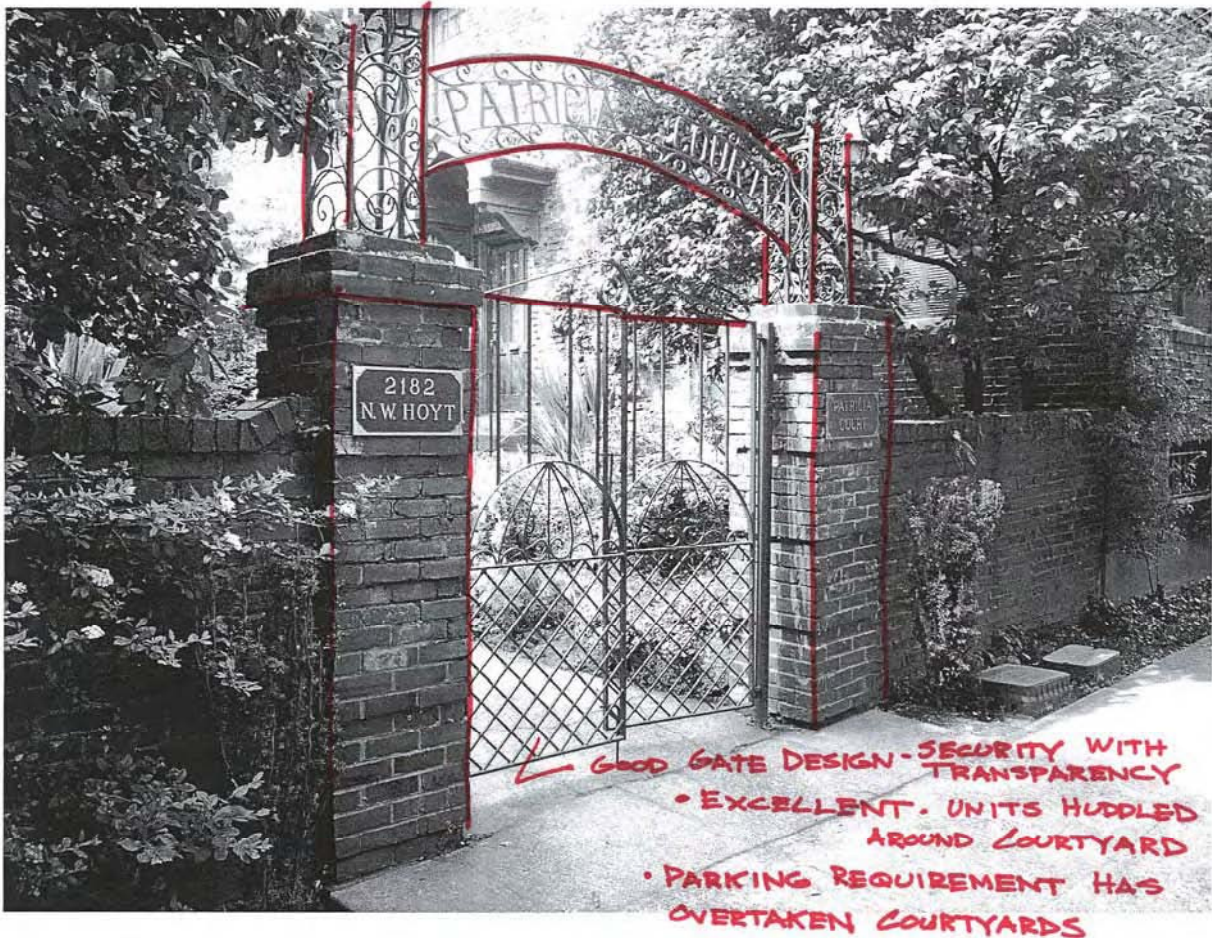
- The entry gate is of good design; it utilizes security with transparency.
- The units huddled position around the courtyard is another good design aspect.
- Parking requirements have overtaken courtyards.
